**Flood Control Project Maintenance
Levee Inspections**
LMA District Cover Sheet
Spring 2016 Levee Inspection Results

Sutter Maintenance Yard East Levee Sacramento River

Spring 2016 Levee Inspection Results

Levee Inspection Report By Mile - Spring 2016

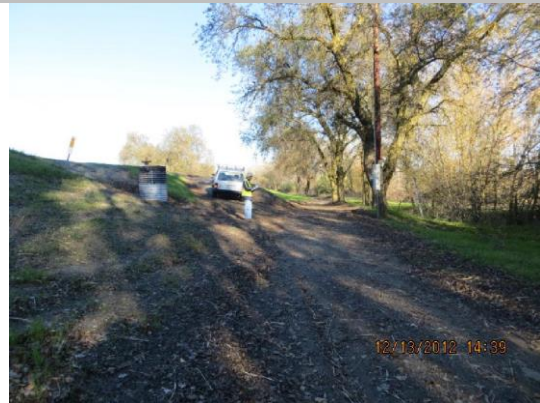
Photo 1 of 2 : UCIP_SP_2016_48511_46983.jpg

Waterside view: overview

Comment Code					
Inspector Comment					
FS_ID:48511 DS_ID:17319 EP_NO: 9527 Repair Type: Urgent Crossing Status: Found UCIP Comments: 4/5/2016 Caved-in slope on landside (LS) not yet repaired. Leaky pipe marker gone. Per Bob Duffey (DWR FPIIB inspector), pipe will be replaced by owner next year. If not, will go to CVFPB enforcement.4/6/2015 Pipe leaks during times of High water. Slope damage still present. needs a more detailed inspection to find the leak.Abandoned and plugged/capped steel pipe on WS berm. DWR leaky pipe marker on LS (12-3). Slope failure on LS. Needs capping of LS steel pipe after detailed investigation.6/30/2014 Same as last inspection.12/30/2013 Same as last inspection.7/29/2013 Pipe does not appear to be abandoned. On the WS it appears that a smaller pipe was sleeved into the 18in. pipe and then the difference capped and welded. Pump was not running at time of inspection but LS ditch near outlet was wet. LS slope damage and leaky pipe marker are still present. FIELD_STRUCT_DESC: 18-inch steel pipe through the levee, 12.5 feet below the crown. Gate valve on the waterside (WS). Vertical pump on the WS bank (Automatic Board Order (ABO) issued as Permit No. 9527, 1974 - Butte Creek Farms) [Additional Reference(s): DWR Levee Log, 2002. USACE Sacramento O&M Manual 136, March 1960] FS Date: 4/5/2016 8:13:00 AM

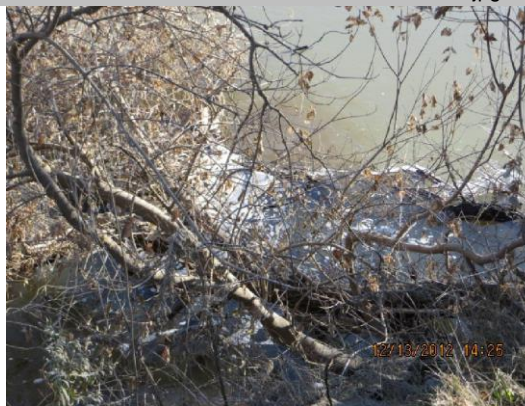
Photo 2 of 2 : UCIP_SP_2016_48512_46991.jpg

FS_ID:48512
DS_ID:17320
EP_NO: 9543
Repair Type: Urgent
Crossing Status: Found
UCIP Comments: 4/5/2016 Erosion on WS slope still present. Pipe still fully submerged on WS and discharging during site visit.4/6/2015 Pipe leaks during high water. DWR employee said he suspects that the flap gate has rotted and fallen off WS end of pipe. Could not locate WS end of pipe to confirm. Water was flowing through this drain during field survey.7/29/2013 Same as last inspection.12/30/2013 Same as last inspection.6/30/2014 Same as last inspection.
FIELD_STRUCT_DESC: 30-inch corrugated metal drainage pipe (at 45 degrees) through the levee, 25.2 feet below the crown. Flap gate on waterside (WS), not found. (Automatic Board Order (ABO) issued as Permit No. 9543, 1974 – Harada) [Additional Reference(s): DWR Levee Log, 2002. USACE Sacramento O&M Manual 136, revision March 1960 (HLM 1.38)]
FS Date: 4/5/2016 8:28:00 AM

Waterside view: water flowing from outlet pipe (pipe fully submerged)

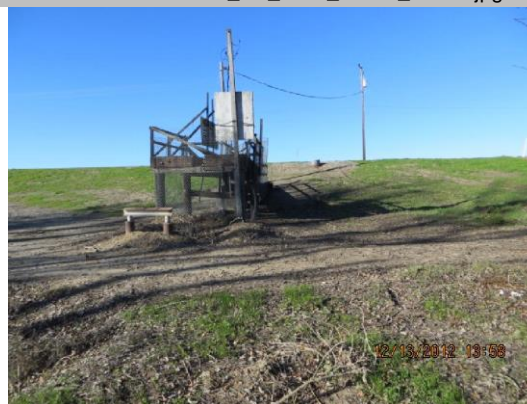
Photo 2 of 2 : UCIP_SP_2016_44138_47003.jpg

FS_ID:44138
DS_ID:17321
EP_NO: 9543
Repair Type: Urgent
Crossing Status: Found
UCIP Comments: 4/6/2015 Sloughing LS slope and river bank. DWR marking for leaky pipe.7/29/2013 Same as last inspection.12/30/2013 Same as last inspection.6/30/2014 Same as last inspection.
FIELD_STRUCT_DESC: 14-inch steel pipe encased in concrete through the levee 12.5 feet below the crown. Slant pump mounted on pile structure on berm. Slide gate in 48-inch riser on berm, walkway to pump. Discharges into concrete distribution box at landward toe. Flap gate on the landward end. (ABO No. 9543 - Harada). O&M manual 136, revision May 2011
FS Date: 4/7/2015 8:41:12 AM

Waterside view: abandoned pump station.

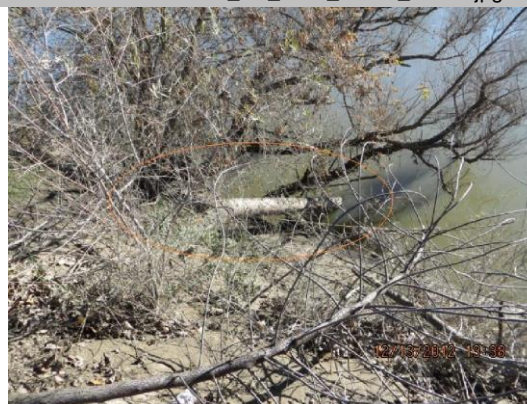
Photo 2 of 2 : UCIP_SP_2016_44139_47011.jpg

FS_ID:44139
DS_ID:17305
EP_NO: 9541
Repair Type: Non-Urgent
Crossing Status: Found
UCIP Comments: CMP standpipe with gate valve. Abandoned pump house. Pipe discharges into open ditch at landward toe- not found.4/6/2015 Same as last inspection.7/29/2013 Same as last inspection.12/30/2013 Same as last inspection.6/30/2014 Same as last inspection.
FIELD_STRUCT_DESC: Abandoned 24-inch pipe through the levee 13.5 feet below the crown, pump in metal house on berm. Slide gate in corrugated metal pipe riser on the waterward slope. Service pole and guy wire anchor on waterward slope. (ABO No. 9541 - Wilbur, McGowan, Zinke). O&M manual 136, revision May 2011
FS Date: 4/7/2015 8:42:33 AM

Waterside view: overview of pipe

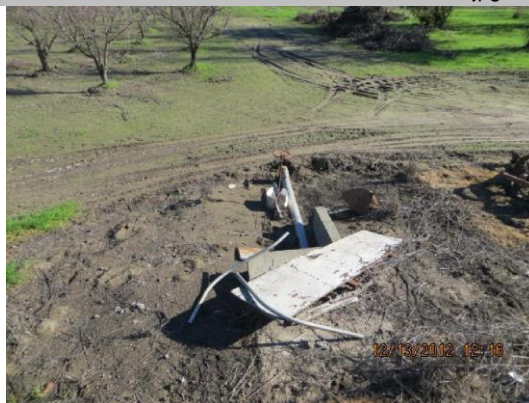
Photo 2 of 2 : UCIP_SP_2016_44146_47046.jpg

FS_ID:44146
DS_ID:17312
EP_NO: 9539
Repair Type: Non-Urgent
Crossing Status: Found
UCIP Comments: 4/6/2015 6in. and 18in. pipes still present in crossing and WS end still plugged with concrete.- it seems that the system was originally designed for drainage, later converted into irrigation system.

Landside view: overview- concrete culvert and pipes

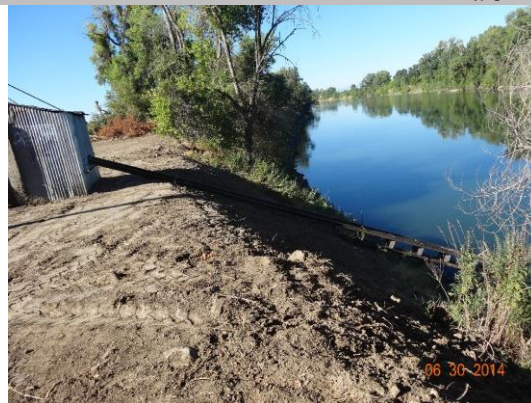
Photo 1 of 2 : UCIP_SP_2016_44167_71480.jpg

FS_ID:44167
DS_ID:17314
EP_NO: 9501
Repair Type: Non-Urgent
Crossing Status: Found
UCIP Comments: 4/6/2015 Same as last inspection. Concrete pit on WS berm. Concrete distribution box on LS silted and erosion around the box. Slope failure/ transverse cracks on LS levee slope. Two depressions on WS berm. 7/29/2013 Repairs to LS slope and pipe are in progress. Nothing has been done yet to the WS depressions. 12/30/2013 Repairs to LS and WS slopes have been completed. Not sure if this is an active or abandoned crossing. LS distribution box is still silted in. 6/30/2014 Crossing appears to be being made active again. WS bank has been cleared of all vegetation and debris to allow pump to slide down to water level. New shutoff valve installed on WS shoulder inside of cmp stand pipe. New air-vac installed inside cmp standpipe on LS shoulder and air vent installed on LS toe. Could not locate pipe end on LS. Need to check for permit number for work done.

WS river bank

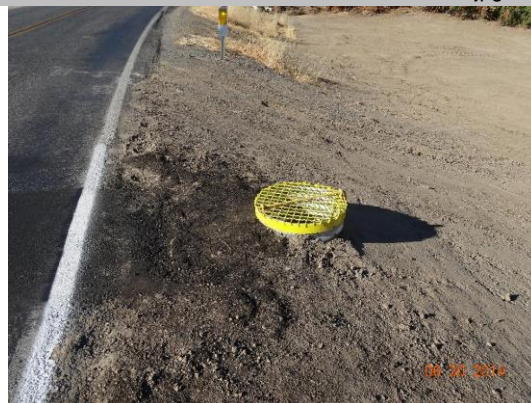
Photo 2 of 2 : UCIP_SP_2016_44167_71479.jpg

WS standpipe with shut off valve inside

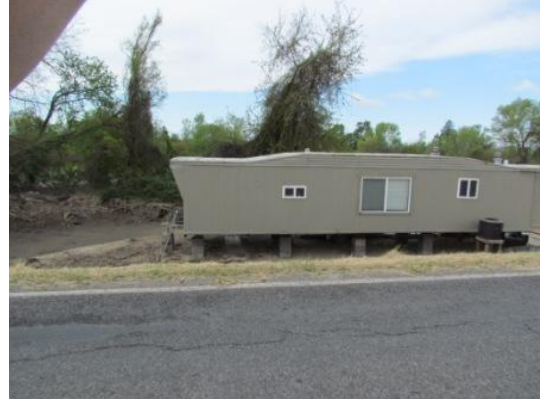
Photo 1 of 1 : SP_2016_ST0003_264_11_20160316_00006.jpg

View of the trailer next to the W/S toe.

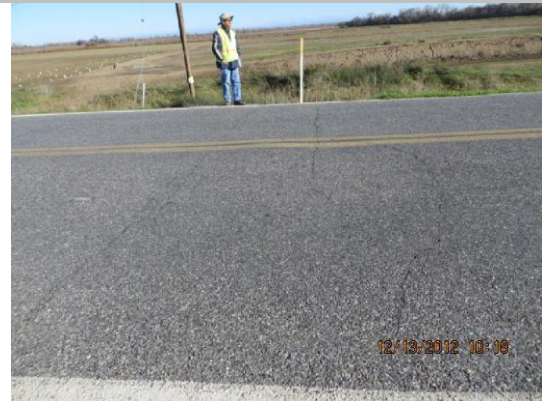
Photo 1 of 2 : UCIP_SP_2016_44174_47068.jpg

Comment Code					
Inspector Comment					
FS_ID:44174 DS_ID:17297 EP_NO: 9501A Repair Type: Non-Urgent Crossing Status: Found UCIP Comments: 4/6/2015 Pump disconnected and pulled up to WS toe. Not Sure if leaky valve has ever been fixed.Motor and pump on berm. Appears an abandoned crossing. Leaky valve on LS slope.Pipe removed and laying on berm. No electric connection to the pump.7/29/2013 Not an abandoned crossing. Pump is connected to WS pipe end at water level and is pumping water to LS and then goes underground to an irrigation ditch about 100yds. upstream. Pump and pipes are disconnected and pulled up to WS toe for high water season. Leaky valve on LS shoulder does not appear to have been fixed.12/30/2013 Same as last inspection.6/30/2014 Same as last inspection. FIELD_STRUCT_DESC: *ABANDONED* 10-inch diameter asphalt coated steel irrigation pipe 5 feet below the crown. Siphon breaker on the landside (LS) shoulder. Motor and pump on waterside (WS) berm. (Permit No. 9501A, 1978 - Mayfair Packing). FS Date: 4/7/2015 10:05:32 AM

Crown view: transverse cracks on levee road.

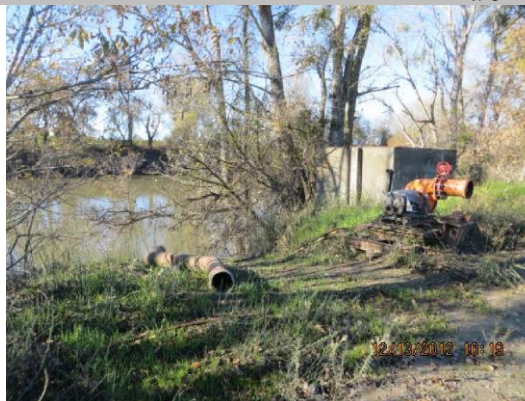
Photo 2 of 2 : UCIP_SP_2016_44174_47067.jpg

Comment Code						
Inspector Comment						
FS_ID:44174 DS_ID:17297 EP_NO: 9501A Repair Type: Non-Urgent Crossing Status: Found UCIP Comments: 4/6/2015 Pump disconnected and pulled up to WS toe. Not Sure if leaky valve has ever been fixed.Motor and pump on berm. Appears an abandoned crossing. Leaky valve on LS slope.Pipe removed and laying on berm. No electric connection to the pump.7/29/2013 Not an abandoned crossing. Pump is connected to WS pipe end at water level and is pumping water to LS and then goes underground to an irrigation ditch about 100yds. upstream. Pump and pipes are disconnected and pulled up to WS toe for high water season. Leaky valve on LS shoulder does not appear to have been fixed.12/30/2013 Same as last inspection.6/30/2014 Same as last inspection. FIELD_STRUCT_DESC: *ABANDONED* 10-inch diameter asphalt coated steel irrigation pipe 5 feet below the crown. Siphon breaker on the landside (LS) shoulder. Motor and pump on waterside (WS) berm. (Permit No. 9501A, 1978 - Mayfair Packing). FS Date: 4/7/2015 10:05:32 AM

Waterside view: overview of pump and abandoned pipe

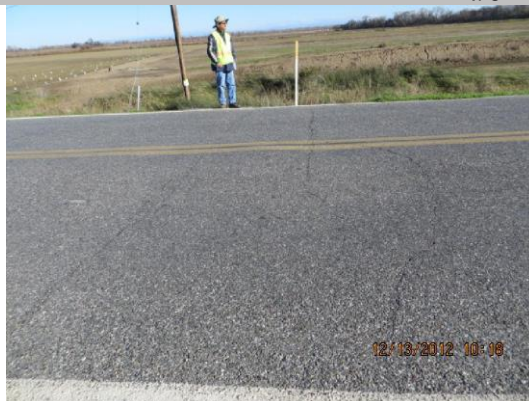
Photo 1 of 2 : UCIP_SP_2016_44175_47080.jpg

FS_ID:44175
DS_ID:17326
EP_NO: 9501
Repair Type: Urgent
Crossing Status: Found
UCIP Comments: 4/6/2015 Same as last inspection. Need to be properly abandoned. Transverse cracks on levee road. Also found a concrete outlet on LS. It is not clear whether this passes through the levee. 7/29/2013 Same as last inspection. 12/30/2013 Same as last inspection. 6/30/2014 Same as last inspection.
FIELD_STRUCT_DESC: *ABANDONED* 16-inch diameter steel irrigation pipe 13.9 feet below the crown. Gate valve and pump in pump house on berm. Flap gate and concrete distribution box on the landside (LS). (Permit No. 9501 - Mayfair Farms, abandoned under Permit No. 9501-A, 1978 - MayFair Packing). O&M manual 136, revision May 2011.
FS Date: 4/7/2015 10:08:17 AM

Crown view: cracks along pipe alignment (transverse crack)

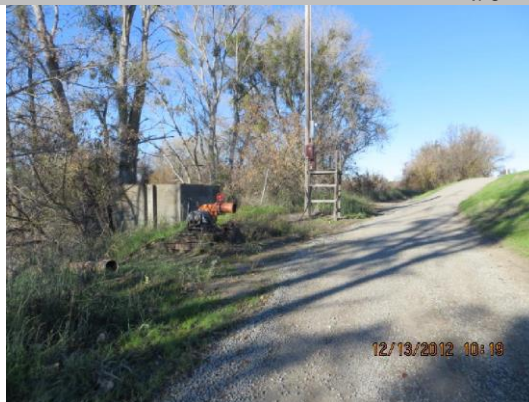
Photo 2 of 2 : UCIP_SP_2016_44175_47079.jpg

Waterside view: overview

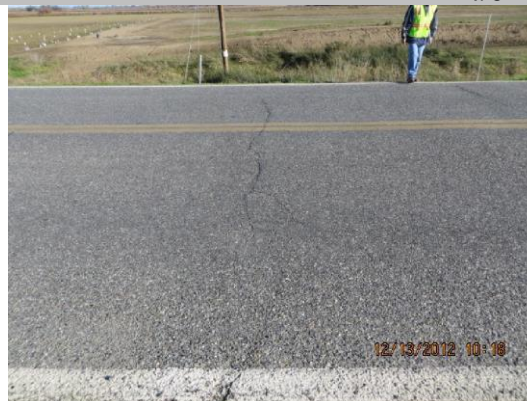
Photo 1 of 2 : UCIP_SP_2016_44176_47087.jpg

LM Start	4.44	Rating **	U	Issue No.	19
LM End	4.44	Issue Type +	En	Location *	WS
Category	Supplemental			GPS Latitude/Longitude	
				Start	End
Item	DWR UCIP Field Study			39.210280 °	39.210280 °
				-121.988284 °	-121.988284 °
DWR ID					
Comment Code					
Inspector Comment					
FS_ID:44176 DS_ID:17484 EP_NO: N/A Repair Type: Urgent Crossing Status: Found UCIP Comments: 4/6/2015 Crossing appears to be an old irrigation structure and not a drain pipe. it appears abandoned as WS surge box is full of debris. Debris and deteriorated concrete. Gate valve in surge tank. 7/29/2013 Same as last inspection. 12/30/2013 Same as last inspection. 6/30/2014 Same as last inspection. FIELD_STRUCT_DESC: 24 inch pipe, 26 ft invert below crown, Slide Gate ws. O&M manual 136, revision May 2011. FS Date: 4/7/2015 10:09:37 AM

Crown view: transverse crack on levee road

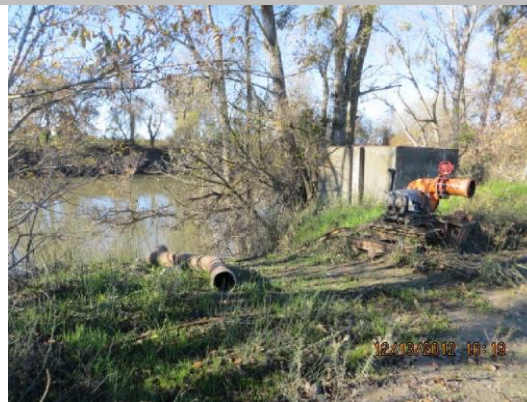
Photo 2 of 2 : UCIP_SP_2016_44176_47086.jpg

Waterside view: overview of concrete surge box

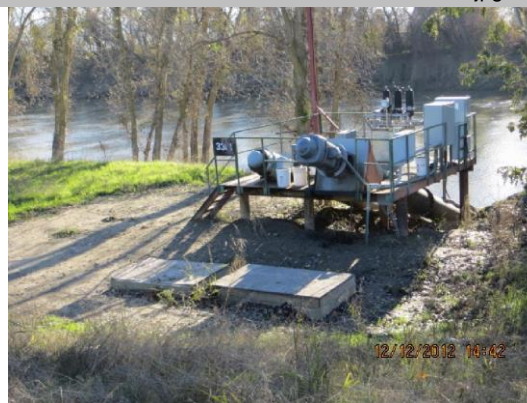
Photo 2 of 2 : UCIP_SP_2016_44177_47091.jpg

FS_ID:44177
DS_ID:17318
EP_NO: 10935
Repair Type: Urgent
Crossing Status: Found
UCIP Comments: 4/6/2015 Erosion problem still present near the LS shoulder. If it gets any worse then it may start to affect the road way. Found a siphon breaker on LS. Antenna and pump station on WS. Huge erosion on LS slope. 7/29/2013 Erosion near LS shoulder may start affecting the roadway if it gets any worse. 12/30/2013 Same as last inspection. 6/30/2014 Same as last inspection.
FIELD_STRUCT_DESC: 24-inch diameter steel pipe 4.0 feet below the crown. Slant pump on the waterside (WS) berm. A siphon breaker is installed on the apex of the pipe and off the levee crown on landside (LS). (Permit No. 9501, 1974 - Mayfair Farms, Inc., Permit No. 10935, 1975 - Pires).
FS Date: 4/7/2015 10:22:41 AM

Waterside view: overview of pump station

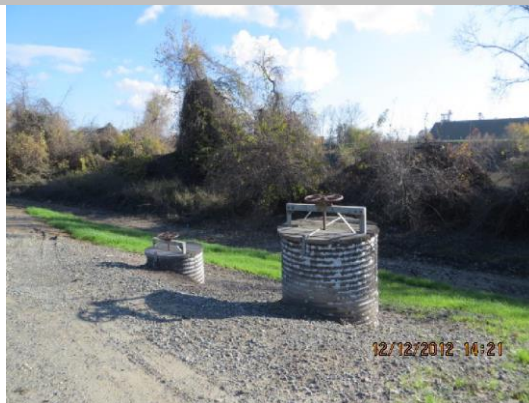
Photo 1 of 2 : UCIP_SP_2016_44179_47107.jpg

Comment Code					
Inspector Comment					
FS_ID:44179 DS_ID:17287 EP_NO: 9520 Repair Type: Non-Urgent Crossing Status: Indicator Found UCIP Comments: 4/6/2015 Same as last inspection. Still appears abandoned.A concrete stand pipe and a CMP riser on WS. It seems abandoned and if so should be done so properly.7/29/2013 Same as last inspection.12/30/2013 Same as last inspection.6/30/2014 Same as last inspection. FIELD_STRUCT_DESC: 24-inch CM drainpipe through the levee 17.0 feet below the crown. Slide gate in CMP riser on the waterward slope. Pump on bank. Concrete standpipe on waterward berm. 18-inch concrete pipe from waterward toe to standpipe. Discharges into field on landward side. (ABO No. 9520 - Arnold). O&M manual 136, revision May 2011. FS Date: 4/7/2015 10:30:26 AM

Waterside view: overview

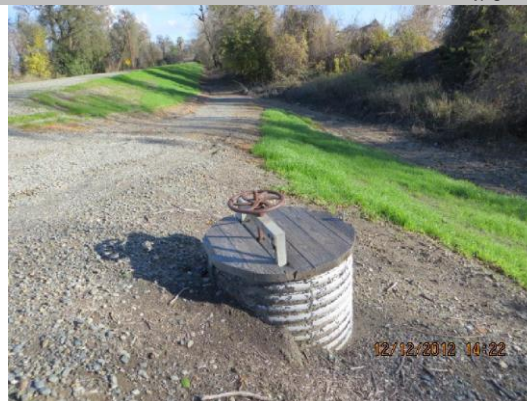
Photo 2 of 2 : UCIP_SP_2016_44179_47106.jpg

Comment Code						
Inspector Comment						
FS_ID:44179						
DS_ID:17287						
EP_NO: 9520						
Repair Type: Non-Urgent						
Crossing Status: Indicator Found						
UCIP Comments: 4/6/2015 Same as last inspection. Still appears abandoned.A concrete stand pipe and a CMP riser on WS. It seems abandoned and if so should be done so properly.7/29/2013 Same as last inspection.12/30/2013 Same as last inspection.6/30/2014 Same as last inspection.						
FIELD_STRUCT_DESC: 24-inch CM drainpipe through the levee 17.0 feet below the crown. Slide gate in CMP riser on the waterward slope. Pump on bank. Concrete standpipe on waterward berm. 18-inch concrete pipe from waterward toe to standpipe. Discharges into field on landward side. (ABO No. 9520 - Arnold). O&M manual 136, revision May 2011.						
FS Date: 4/7/2015 10:30:26 AM

Waterside view: CMP riser with slide gate

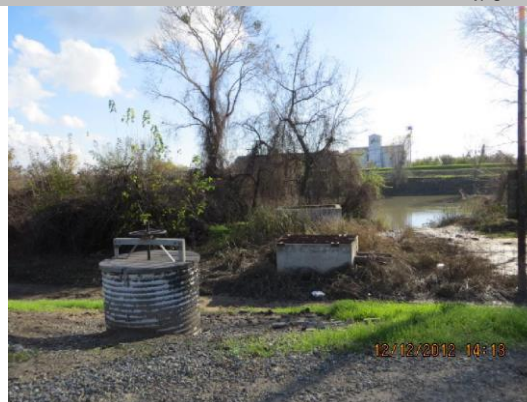
Photo 2 of 2 : UCIP_SP_2016_44182_47113.jpg

FS_ID:44182
DS_ID:17289
EP_NO: 2904
Repair Type: Urgent
Crossing Status: Found
UCIP Comments: 4/6/2015 Repairs are in progress to this crossing. Surge box on WS and distribution box across the county road on LS. Abandoned pump station and electrical panel on WS. A concrete pump pit on WS. 7/29/2013 Portable tow-pump lowered down WS berm to water level and is pumping water into concrete surge box on WS and the filling the irrigation ditch on LS. Sink hole with standing water that is present above the outlet pipe for the WS surge box. This may indicate a leaking pipe or cracked concrete. 12/30/2013 Sink Hole above pipe on WS still present. Pipe end inside of WS surge box shows heavy signs of rust and corrosion. Recommend having an internal camera inspection completed on pipe. 6/30/2014 Sink hole near WS surge box is still present. Portable pumps were lowered down the WS bank and were pumping water directly into WS standpipe on to by pass the surge box. FIELD_STRUCT_DESC: 36-inch corrugated metal pipe through the levee 18.4 feet below the crown. Slide gate in corrugate metal pipe riser on waterward shoulder, pump and concrete pump pit on the waterward bank. Concrete surge box on the waterward berm. Discharges into irrigation ditch on the opposite side of the county road. (App. No. 2904 - Arnold). Application was for an existing pumping system. O&M manual 136, revision May 2011.

Waterside view: CMP riser and surge box

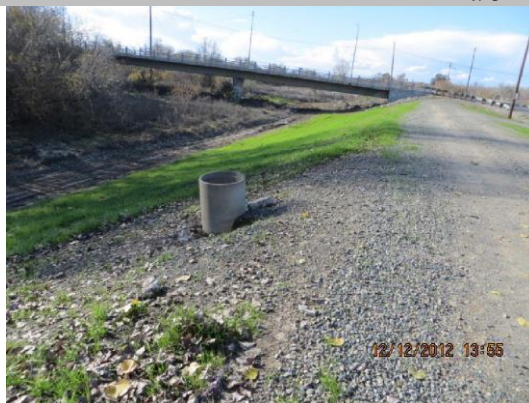
Photo 1 of 2 : UCIP_SP_2016_44187_47127.jpg

LM Start	5.15	Rating **	M	Issue No.	23
LM End	5.15	Issue Type +	En	Location *	CR
Category	Supplemental			GPS Latitude/Longitude	
				Start	End
Item	DWR UCIP Field Study			39.215409 °	39.215409 °
				-121.999061 °	-121.999061 °
DWR ID					
Comment Code					
Inspector Comment					
FS_ID:44187 DS_ID:17291 EP_NO: 4091 Repair Type: Non-Urgent Crossing Status: Found UCIP Comments: 4/6/2015 Same as last inspection. Crossing appears abandoned. Appears abandoned and if so should be done so properly. No Siphon breaker found on LS. 7/29/2013 Same as last inspection. 12/30/2013 Same as last inspection. 6/30/2014 Same as last inspection. FIELD_STRUCT_DESC: Abandoned 8-inch steel pipe through the levee 4.0 feet below the crown. Pump on bank. Gate valve in concrete pipe riser on waterward shoulder. (App. No. 4091 - Halsey). FS Date: 4/7/2015 10:50:39 AM

Waterside view: concrete pipe riser with gate valve

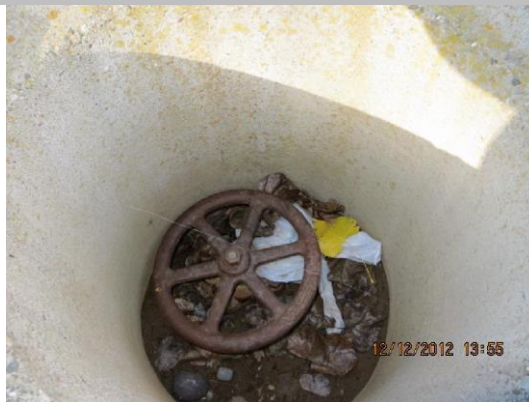
Photo 2 of 2 : UCIP_SP_2016_44187_47126.jpg

Waterside view: buried gate valve in concrete pipe riser

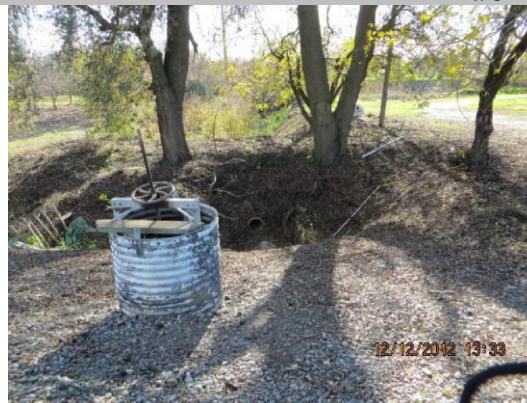
Photo 1 of 2 : UCIP_SP_2016_44207_47136.jpg

FS_ID:44207
DS_ID:17293
EP_NO: 9514
Repair Type: Urgent
Crossing Status: Found
UCIP Comments: 4/1/2015 PVC pipe still runs through crossing. WS end has been covered and blocked with sandbags to prevent water flow during high water season.- Water transfer ditch and CMP riser on WS7/23/13 8inch pvc running through pipe preventing slide gate from closing. No positive pipe closure for high water season. Stem on WS screw gate is bent.12/18/2013 Same as last inspection. Levee inspections is working with land owner to solve this issue.6/30/2014 Same as last inspection.
FIELD_STRUCT_DESC: 24-inch corrugated metal pipe through the levee, slide gate in corrugated metal pipe riser. Concrete headwall on waterward berm, pump on riverbank. Discharges in field at landward toe. Irrigation ditch across waterward berm to headwall. (ABO No. 9514 - Boggs). Pipe invert 11.0 ft below crown. O&M manual 136, revision May 2011.

Waterside view: CMP riser with slide gate

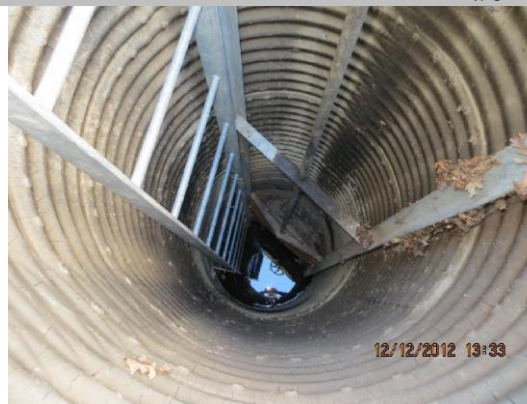
Photo 2 of 2 : UCIP_SP_2016_44207_47135.jpg

Waterside view: inside CMP riser

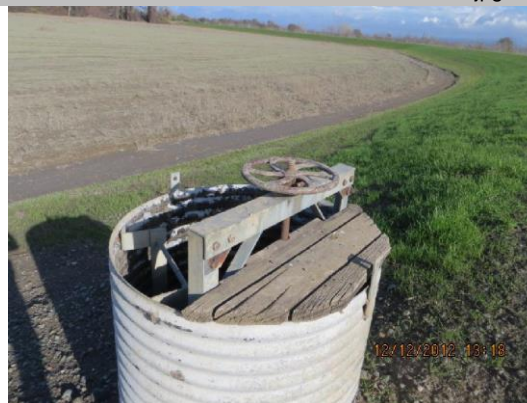
Photo 2 of 2 : UCIP_SP_2016_44208_47147.jpg

FS_ID:44208
DS_ID:17294
EP_NO: 9514
Repair Type: Urgent
Crossing Status: Found
UCIP Comments: 4/1/2015 PVC pipe still runs through crossing. WS end has been covered and blocked with sandbags to prevent water flow during high water season. 36-inch CMP found instead of 30-inch CMP. LS pipe tampered. 7/23/2013 8inch PVC pipe ran through 36inch CMP preventing screw gate from closing for high water season. 12/18/2013 Same as last inspection. Levee inspections is working with land owner to solve the issue. 6/30/2014 Same as last inspection.
FIELD_STRUCT_DESC: 36-inch corrugated metal drainpipe through the levee 12.0 feet below the crown. Slide gate in corrugated metal pipe riser on the waterward slope. (ABO No. 9514 - Boggs). O&M manual 136, revision May 2011.
FS Date: 4/7/2015 12:47:32 PM

Waterside view: CMP riser with slide gate

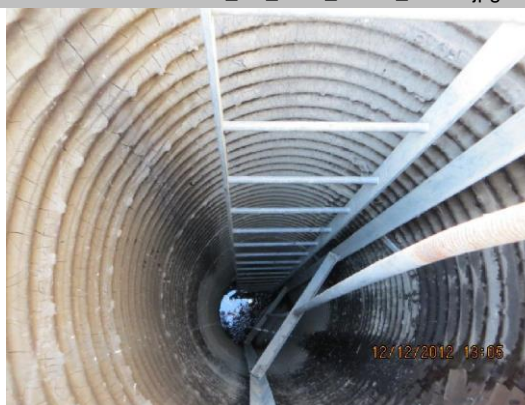
Photo 2 of 2 : UCIP_SP_2016_44209_47156.jpg

LM Start	6.40	Rating **	M	Issue No.	29
LM End	6.40	Issue Type +	En	Location *	CR
Category	Supplemental			GPS Latitude/Longitude	
				Start	End
Item	DWR UCIP Field Study			39.223796 °	39.223796 °
				-121.999014 °	-121.999014 °
DWR ID					
Comment Code					
Inspector Comment					
FS_ID:44209 DS_ID:17306 EP_NO: 9530 Repair Type: Non-Urgent Crossing Status: Found UCIP Comments: 4/1/2015 WS pipe end 3/4 blocked by soil. LS end is still unknown.Pipe outlet on WS partially burried, it needs cleaning.7/23/2013 Same as last inspection12/18/2013 Same as last inspection.6/30/2014 Same as last inspection. FIELD_STRUCT_DESC: 30-inch corrugated metal drainpipe through the levee 15.0 feet below the crown. Slide gate in corrugated metal pipe riser on the waterward slope. (ABO No. 9530 - Halsey). FS Date: 4/7/2015 12:52:21 PM

Waterside view: inside CMP riser

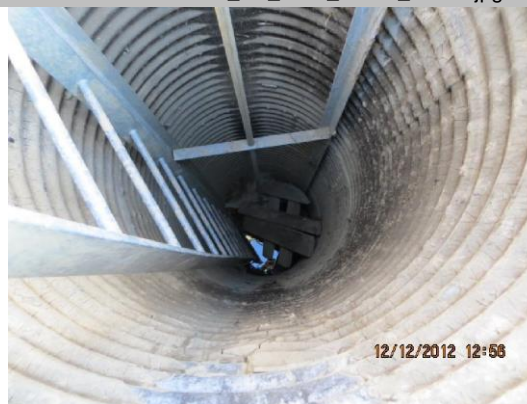
Photo 2 of 2 : UCIP_SP_2016_44211_47180.jpg

Comment Code					
Inspector Comment					
FS_ID:44211 DS_ID:17296 EP_NO: 9530 Repair Type: Non-Urgent Crossing Status: Found UCIP Comments: 4/1/2015 Only cmp riser with screwgate found on WS. Screwgate stem is bent.Appears abandoned and should be verified as having been done so properly. Only CMP riser with slide gate found on WS7/23/2013 Same as last inspection12/18/2013 Same as last inspection.6/30/2014 Same as last inspection. FIELD_STRUCT_DESC: 24-inch corrugated metal drainpipe through the levee 13.5 feet below the crown. Slide gate in corrugated metal pipe riser on waterward slope. (ABO No. 9530 - Halsey). O&M manual 136, revision May 2011. FS Date: 4/7/2015 12:58:28 PM

Waterside view: inside CMP riser

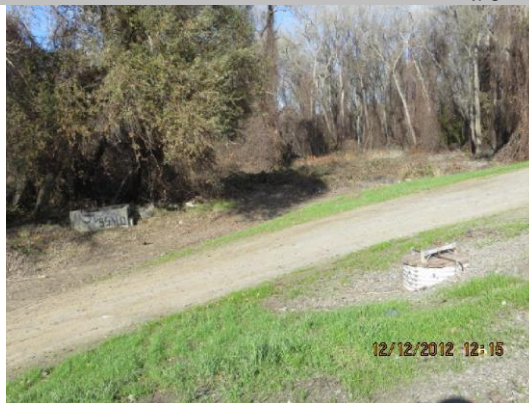
Photo 1 of 2 : UCIP_SP_2016_44224_47189.jpg

FS_ID:44224
DS_ID:17300
EP_NO: N/A
Repair Type: Non-Urgent
Crossing Status: Found
UCIP Comments: 4/1/2015 Only cmp riser and slide gate found on WS. Abandoned riser with slide gate on WS. Abandoned concrete surge box on WS. Verify pipe has been abandoned properly.

Waterside view: overview

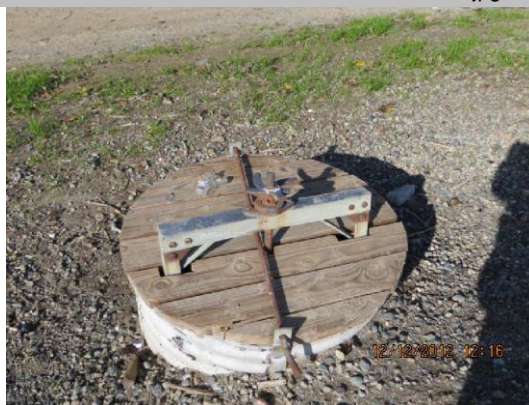
Photo 2 of 2 : UCIP_SP_2016_44224_47188.jpg

Waterside view: CMP riser with slide gate

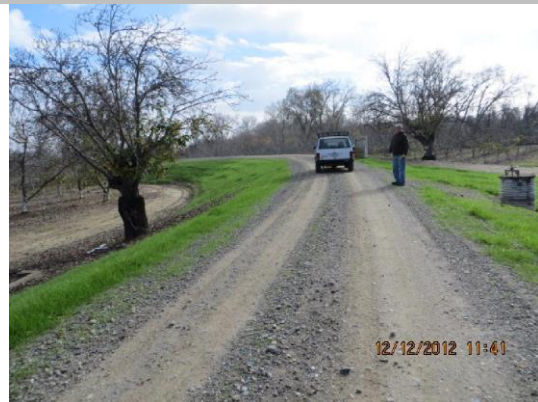
Photo 1 of 2 : UCIP_SP_2016_44229_47202.jpg

Comment Code					
Inspector Comment					
FS_ID:44229 DS_ID:17304 EP_NO: 9529 Repair Type: Non-Urgent Crossing Status: Found UCIP Comments: 4/1/2015 CMP riser and slidegate on WS. LS distribution box is silted in.Looks abandoned. CMP riser with slide gate on WS. Concrete distribution box on LS- full with silt.7/23/2013 Same as last inspection.12/18/2013 Same as last inspection.6/30/2014 Same as last inspection. FIELD_STRUCT_DESC: 24-inch corrugated metal pipe through the levee, slide gate CMP riser on the waterward slope. Concrete box at the landward toe. Pipe invert 12.8 ft below crown. (ABO No. 9529 - Dorwood Ranch)O&M manual 136, revision May 2011. FS Date: 4/7/2015 1:30:35 PM

Crown view: overview (both sides of the levee)

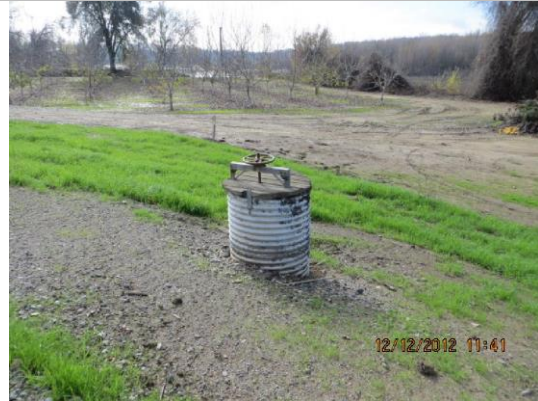
Photo 2 of 2 : UCIP_SP_2016_44229_47201.jpg

Waterside view: overview of CMP riser

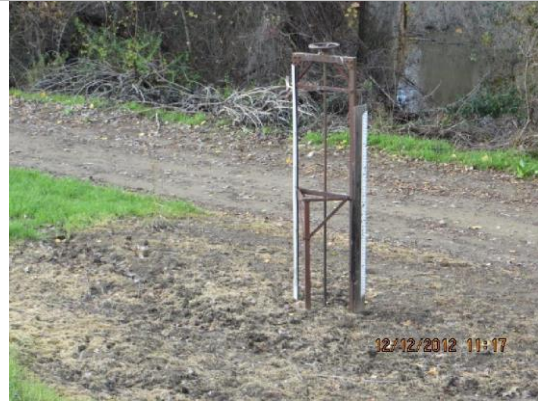
Photo 2 of 2 : UCIP_SP_2016_47702_47209.jpg

Waterside view: buried slide gate

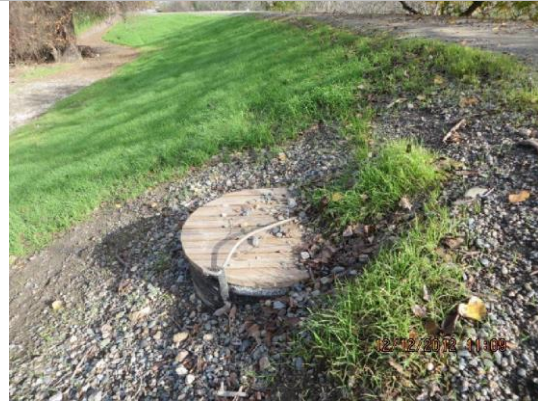
Photo 2 of 2 : UCIP_SP_2016_47707_74661.jpg

42-inch riser on WS shoulder.

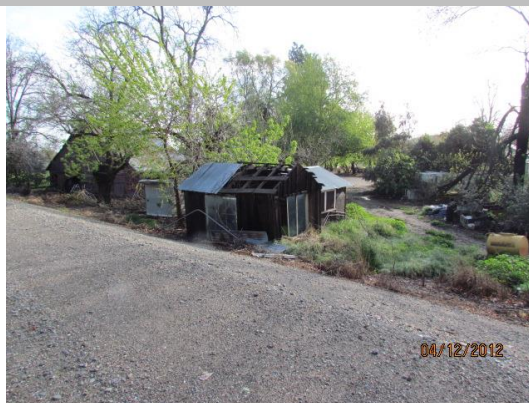
Photo 1 of 1 : SP_2016_ST0003_264_2_20160316_00002.jpg

View of the building next to the toe of the levee.

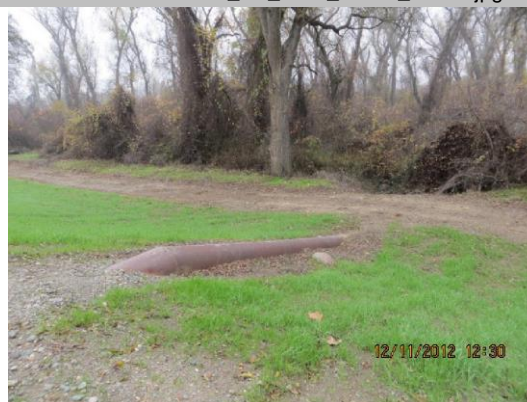
Photo 2 of 2 : UCIP_SP_2016_44449_47283.jpg

Waterside view: overview of exposed steel pipe

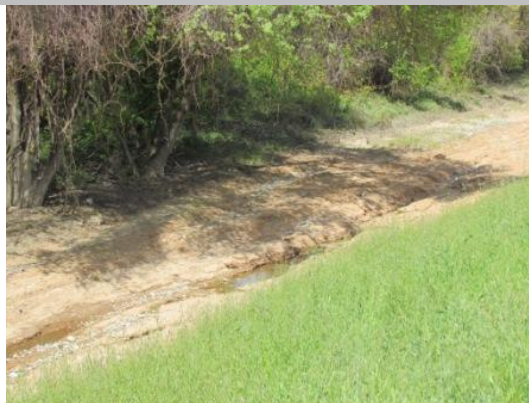
Photo 1 of 1 : SP_2016_ST0003_264_9_20160316_00005.jpg

View of the erosion along the W/S toe.

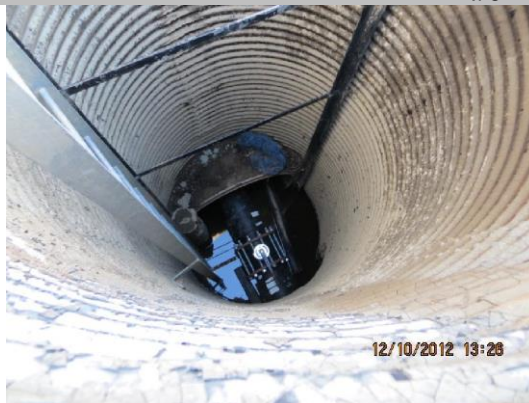
Photo 2 of 2 : UCIP_SP_2016_48078_47362.jpg

Waterside view: new steel pipe sleeved through CMP pipe.

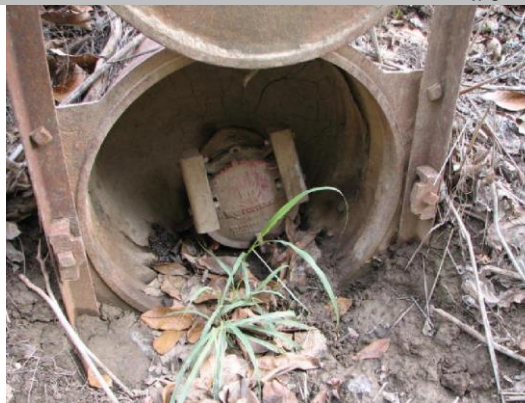
Photo 2 of 2 : UCIP_SP_2016_48105_47441.jpg

Waterside view: 8-inch pipe inside 24-inch CMP

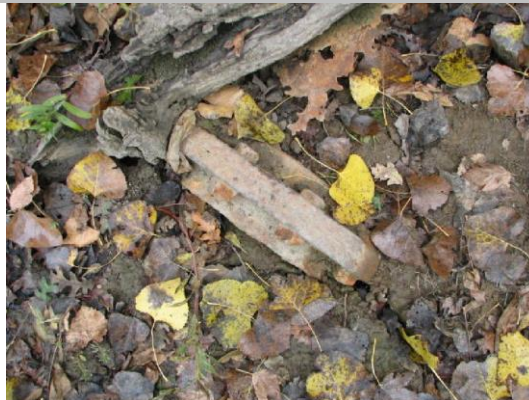
Photo 2 of 2 : UCIP_SP_2016_44500_47448.jpg

Waterside view: abandoned and ruined pipe

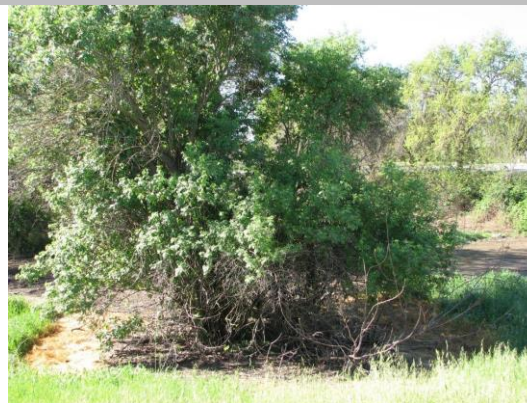
Photo 1 of 1 : SP_2016_ST0003_265_1_20160405_00004.jpg

Elderberry

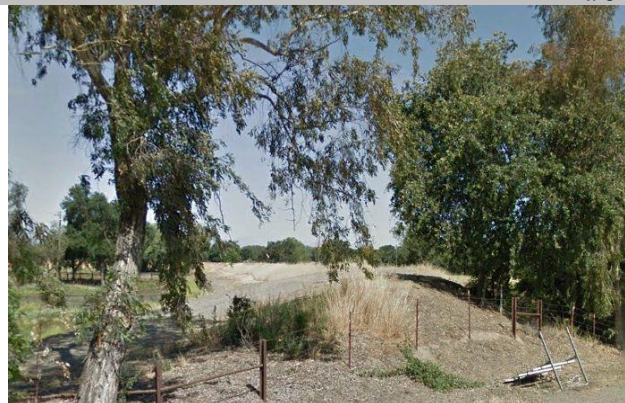
Photo 1 of 1 : SP_2016_ST0003_267_1_20160517_00001.jpg

3/22/2016: Vegetation maintained at a minimal level.

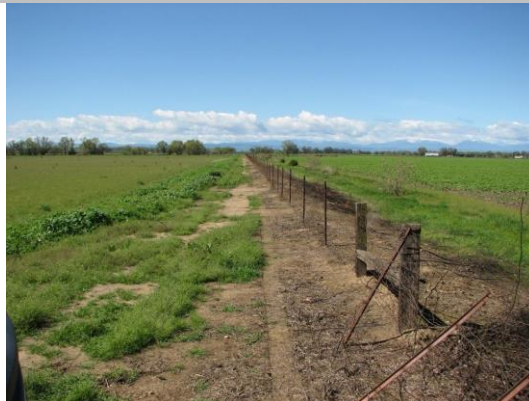
Photo 1 of 1 : SP_2016_ST0003_268_1_20160405_00001.jpg

Fence obstructing access
